NATIONAL PROGRAM FOR INSPECTION OF NON-FEDERAL DAMS  
MOLLYMOCKET BROOK DAM. (U) CORPS OF ENGINEERS WALTHAM  
MA NEW ENGLAND DIV FEB 79

MOLLYWCKET BROOK DAM  
N.H. 00076

# PHASE I INSPECTION REPORT NATIONAL DAM INSPECTION PROGRAM

FEBRUARY 1979

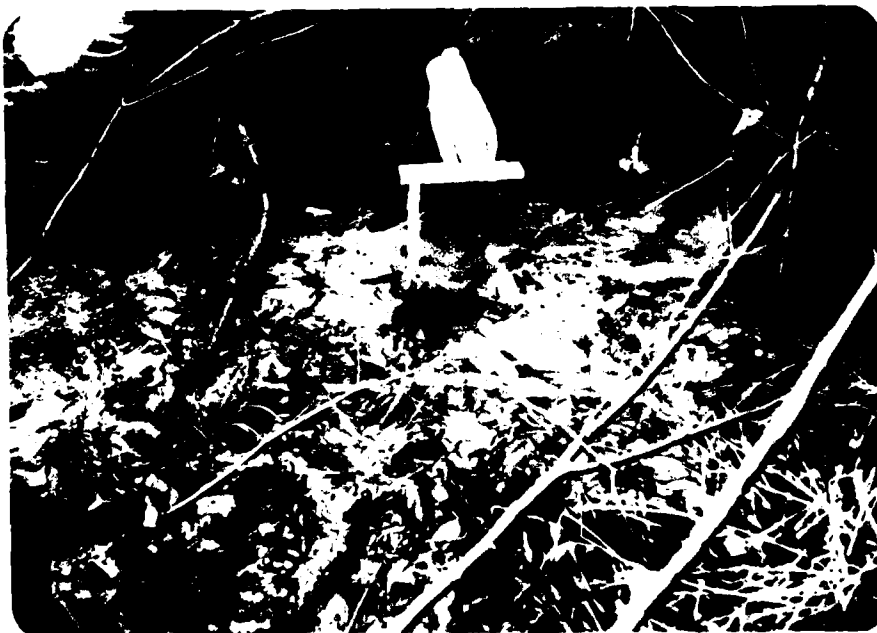
#2. VIEW OF BOIL AND SEEP AREA

An area of seeps and boils was observed about 4 feet downstream of the toe about 60 feet to the left of the spillway's left training wall. The area of boils is about 5 feet by 3 feet and is covered with brown silt and fine sand. The silt and sand are also evident further downstream where it is transported by the water from the seeps. A view of the area of boils is shown in Photo 2. A small hole excavated in the boils area disclosed a 3-inch layer of brown silt and sand with tree leaves. At the bottom of the 3-inch layer, a gravelly sand was exposed.

5. Repair or replacement of the waste gate.
6. Investigation of the embankment and foundation materials to ascertain the significance of the seep and boil area and the design of measures to prevent future piping.

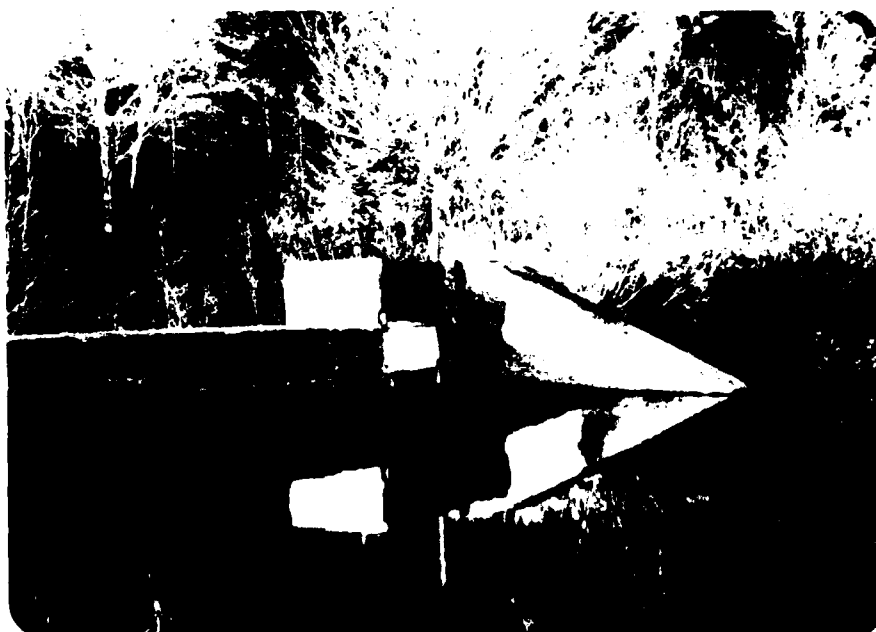
#4. VIEW OF UPSTREAM SPILLWAY FACE

Major cracking of the spillway and training walls appears to be associated with the original construction jointing. A comparison of Photos 4 and 5, showing both upstream and downstream faces of the spillway, indicates that the observed cracks may extend through the full width of the spillway.

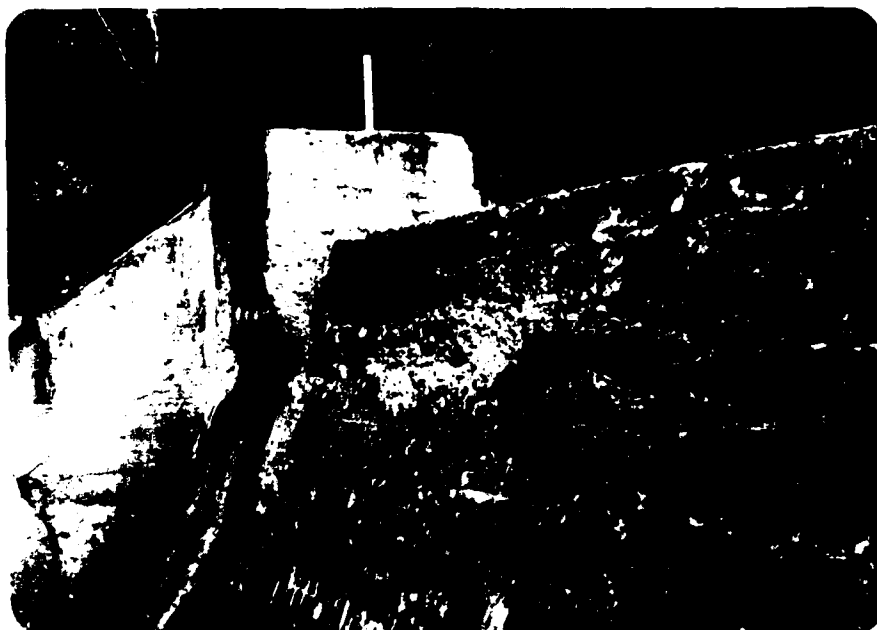
The concrete spillway structure was found to be in very poor condition. Spalling and cracking of all exposed surfaces is extensive. At one location above the waste gate conduit the spalling has extended approximately one foot into the downstream face of the spillway. The spalling at this location has been intensified by seepage through the spillway with obvious freeze-thaw action speeding the surface spalling process (see Photos 5, 7, 8 and 9).

#5. VIEW OF DOWNSTREAM SPILLWAY FACE SHOWING  
CRACKED AND SPALLING CONCRETE

1. Repair and stabilization of the right training wall.
2. Installation of an energy dissipating apron at the base of the dam.
3. Repair and/or replacement of the spalled concrete.
4. Seal of leakage through spillway above waste gate.
